# Introduction to the Workshop

The current workshop is part of an extensive research project, aiming to investigate the effect of interfaces, reinforced using vertical connectors (gomfoi) on the seismic behaviour of ancient monuments. The research focuses on the seismic behaviour of columns and colonnades, where shear connectors cross the interfaces between consecutive drums.

- Title of the research project: ***Reinforced Interfaces between structural members in Ancient MONuments***
- Proposal of the research project: March 2021
- Initial Approval of the research project: May 2022
- Research project starting date: October 2022
- Initial Idea: *Gomfoi* are mainly known to connect horizontal members but in some cases they are used for the connection of the drums of the columns, in the Hellenistic and Roman Era.

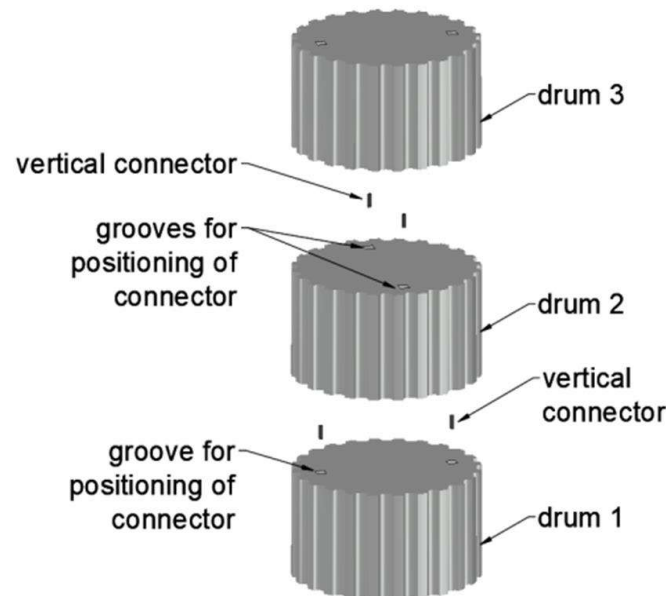
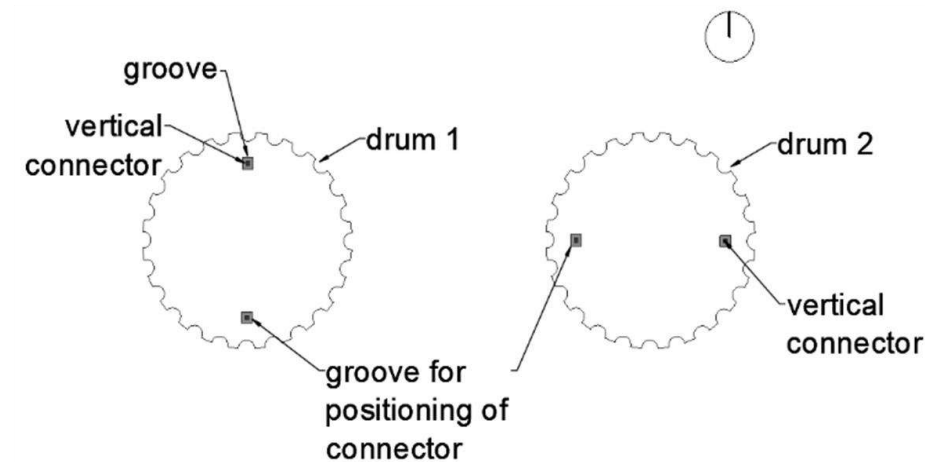
In most cases, the reinforced columns have a slenderness ratio greater than 1.0. Recent restoration works at the Olympieion, Athens, have revealed the arrangement of vertical connectors shown in the Figure.

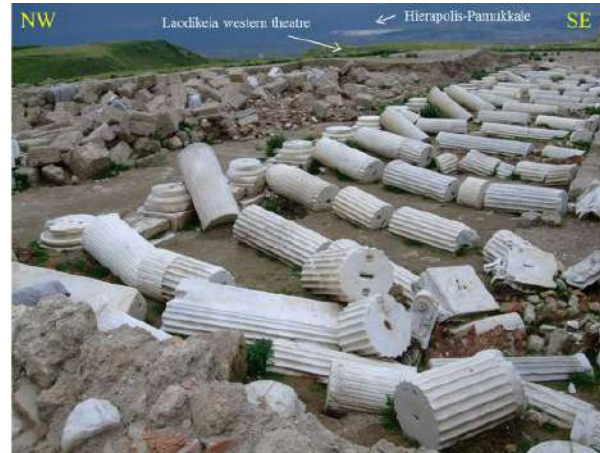
Collapsed wall and columns of west portik in Laodikeia.  
 Kumsar et al., 2015

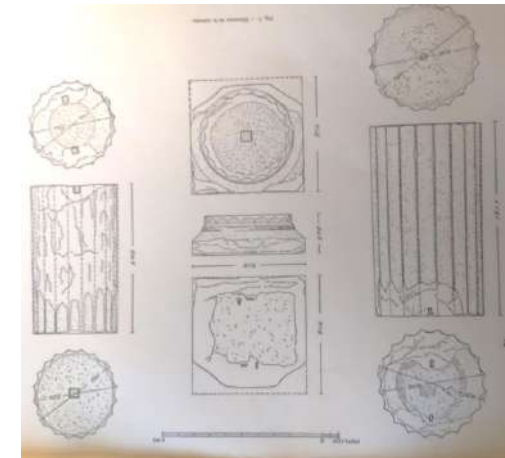
The Temple of the Twelve Gods (Dodecatheon), and the positions of the grooves. Jean and Will, 1955.

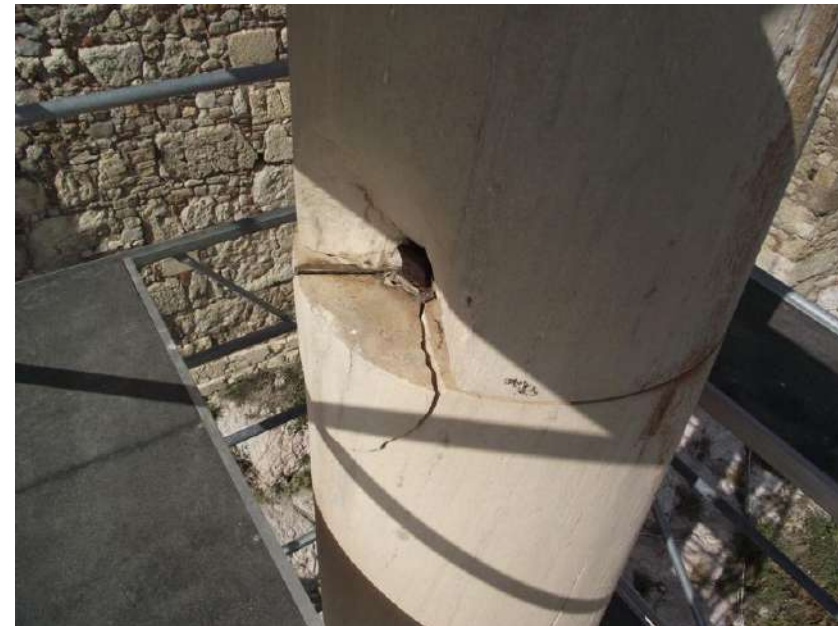
A vertical connector with lead between the fifth and the sixth drums, in the east column (Two choregic columns on the South flank of the Acropolis).  
 Zambas et al., 2011.

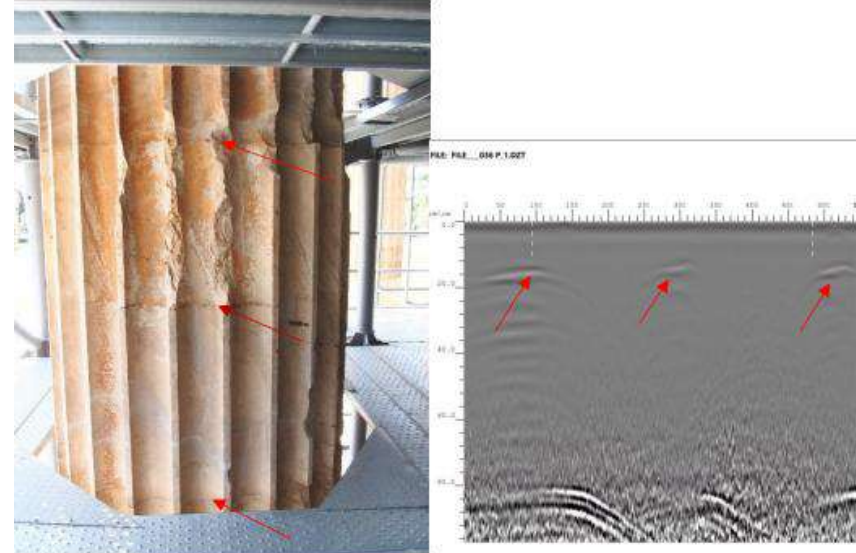
Column A3. Flut "η". Traces of lead between successive drums

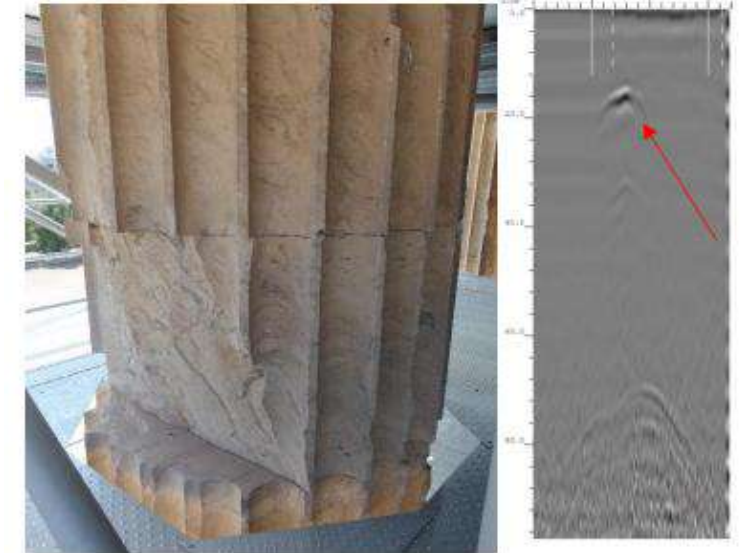
Column A1. Flut "η". No traces of lead between the drums

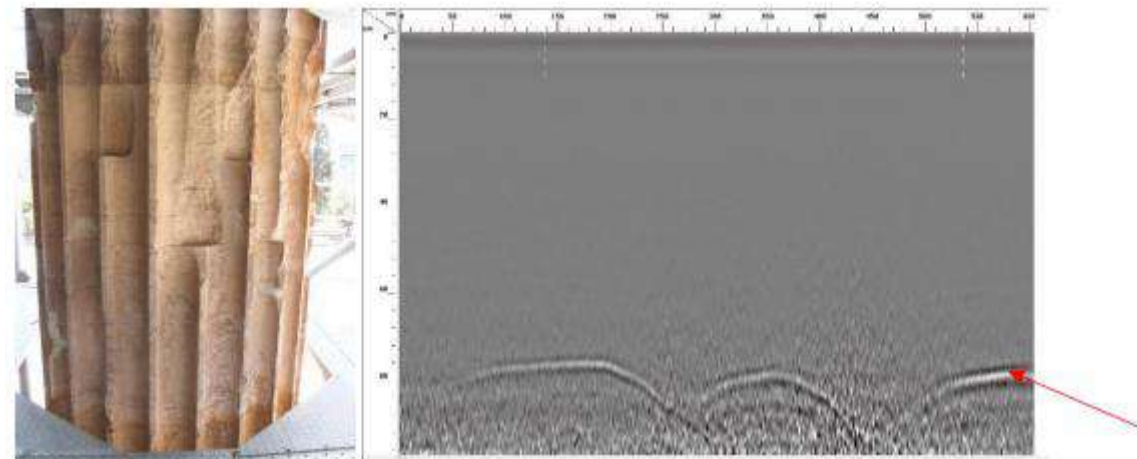
Column A3. Flut "α". No traces of lead

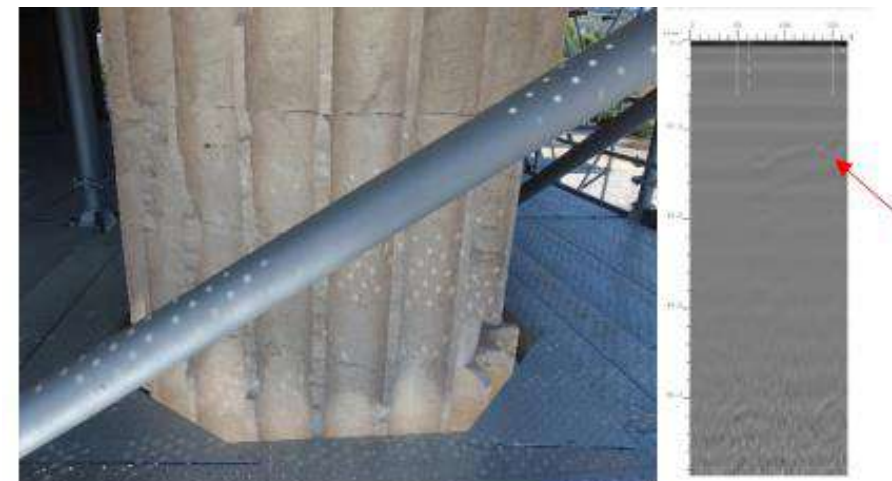
Column A1. Flut "α". No traces of lead between the drums

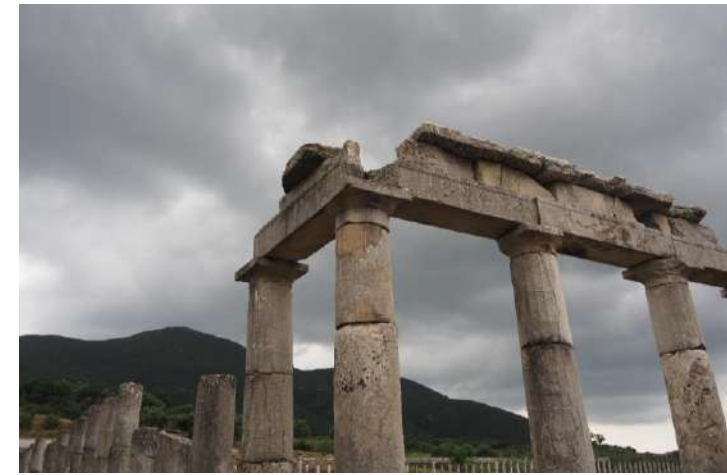
→ The construction of the corner and the epistyles

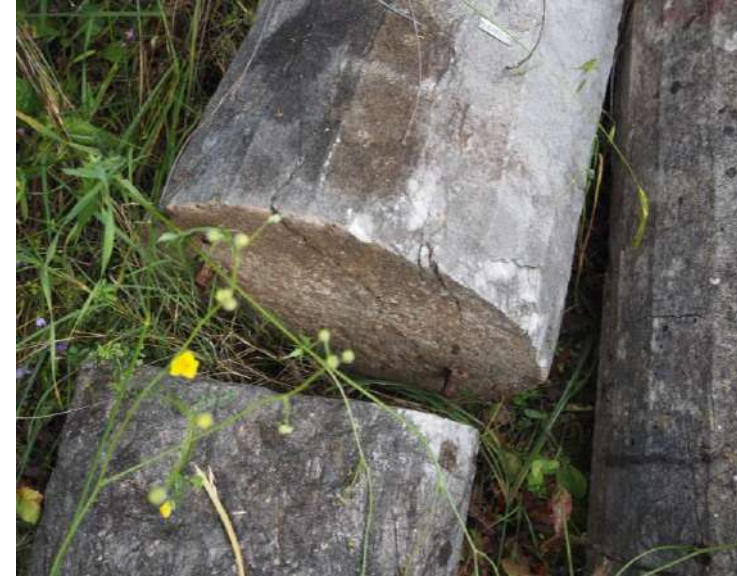
Drums with grooves and connectors →
